# Instructions for replacing the Worm Gear in an Actuator

INS - 24 Approved by: \_\_\_\_\_ Date \_\_\_\_\_

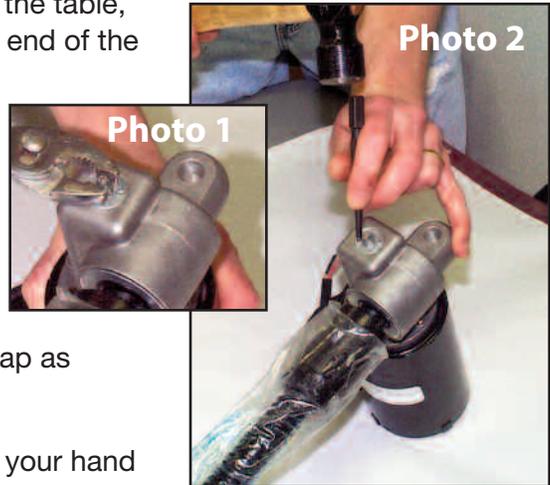
2. If your table has a grease fitting (see Photo 1), first remove it with a pliers or adjustable wrench.
